PAPSON Properties

Professional Property Inspectors

Narrative Report

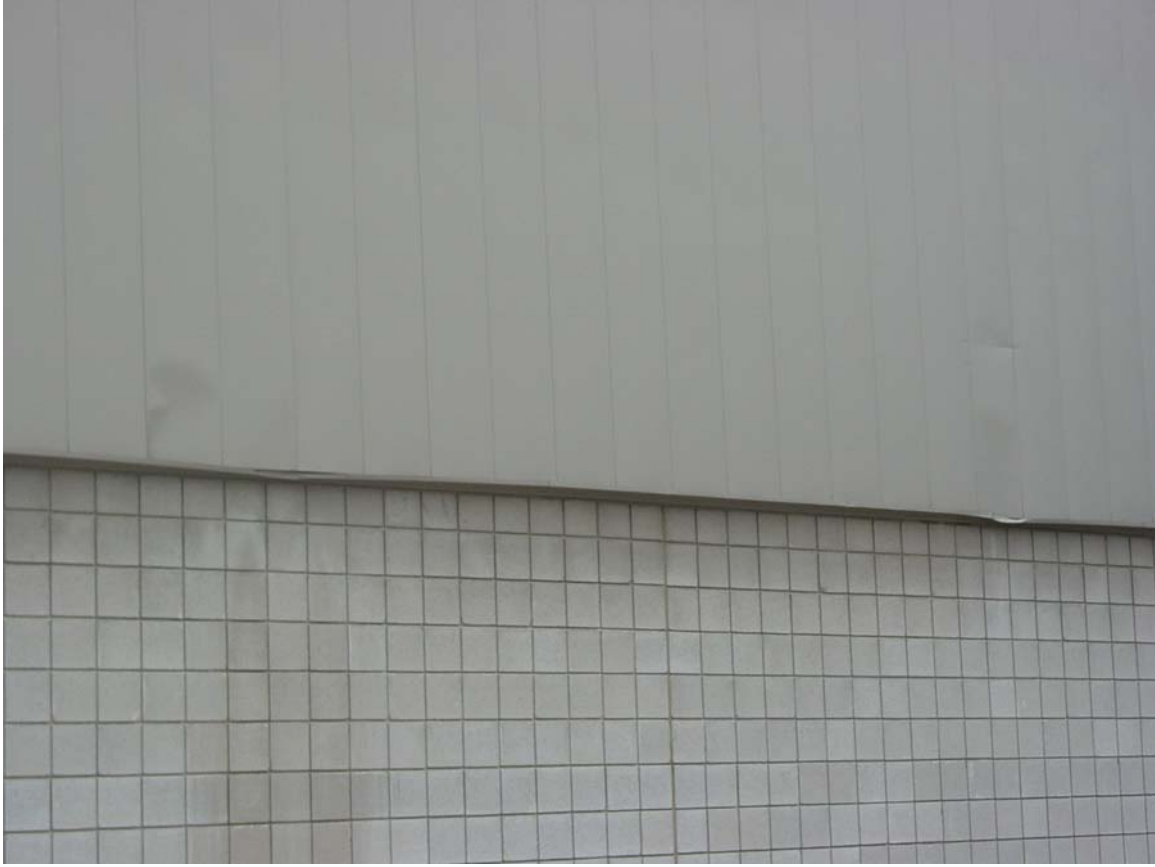
Minor damage to metal siding.

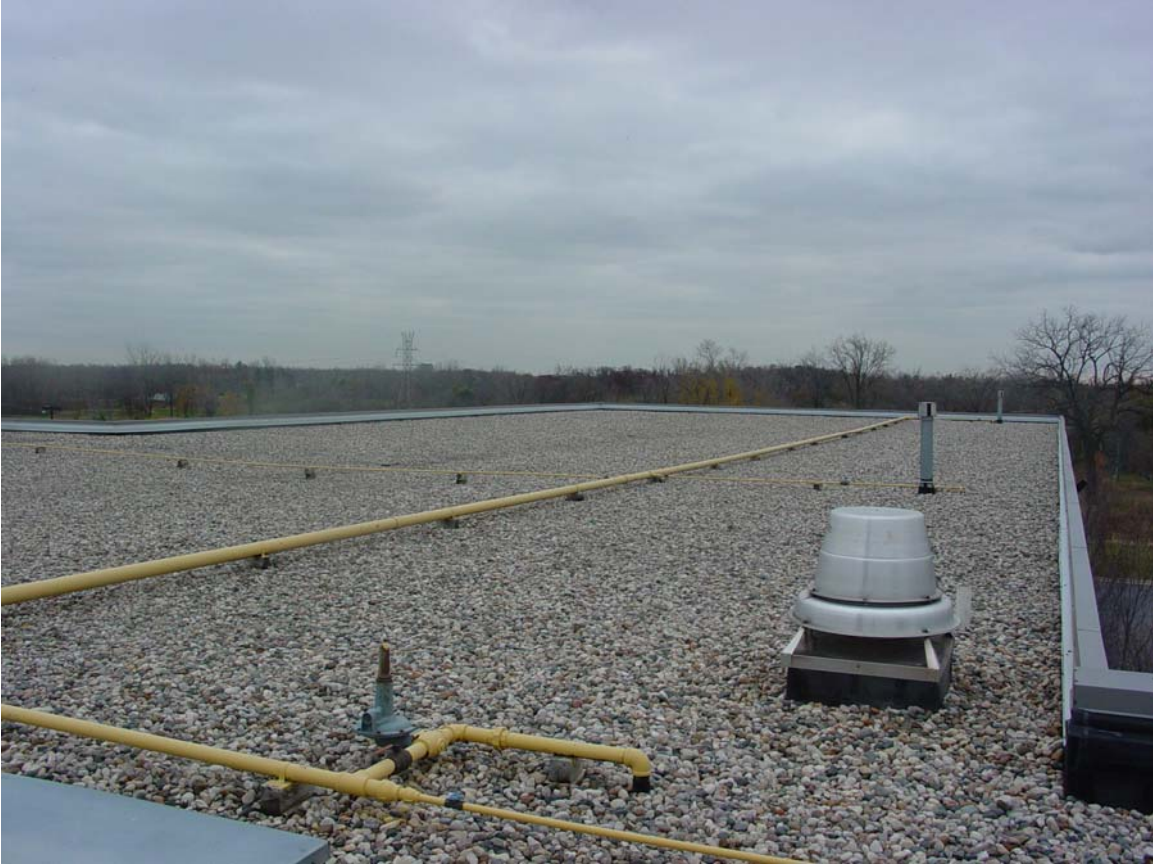
Roof

The roof is constructed of a Carlisle roofing material which has a useful life of 15 - 20 years. The roof is currently 10 years old and is wearing well for its age. There is some shrinkage occurring in a couple of areas this should be monitored over time. The remainder of the roof has been maintained well with regular repairs to leaks and repairs to expansion joints as needed. The roof replacement is scheduled in 4 years with a budget of \$459,250.00, the current condition is good however, we feel in 4 years the roof may need to be replaced.

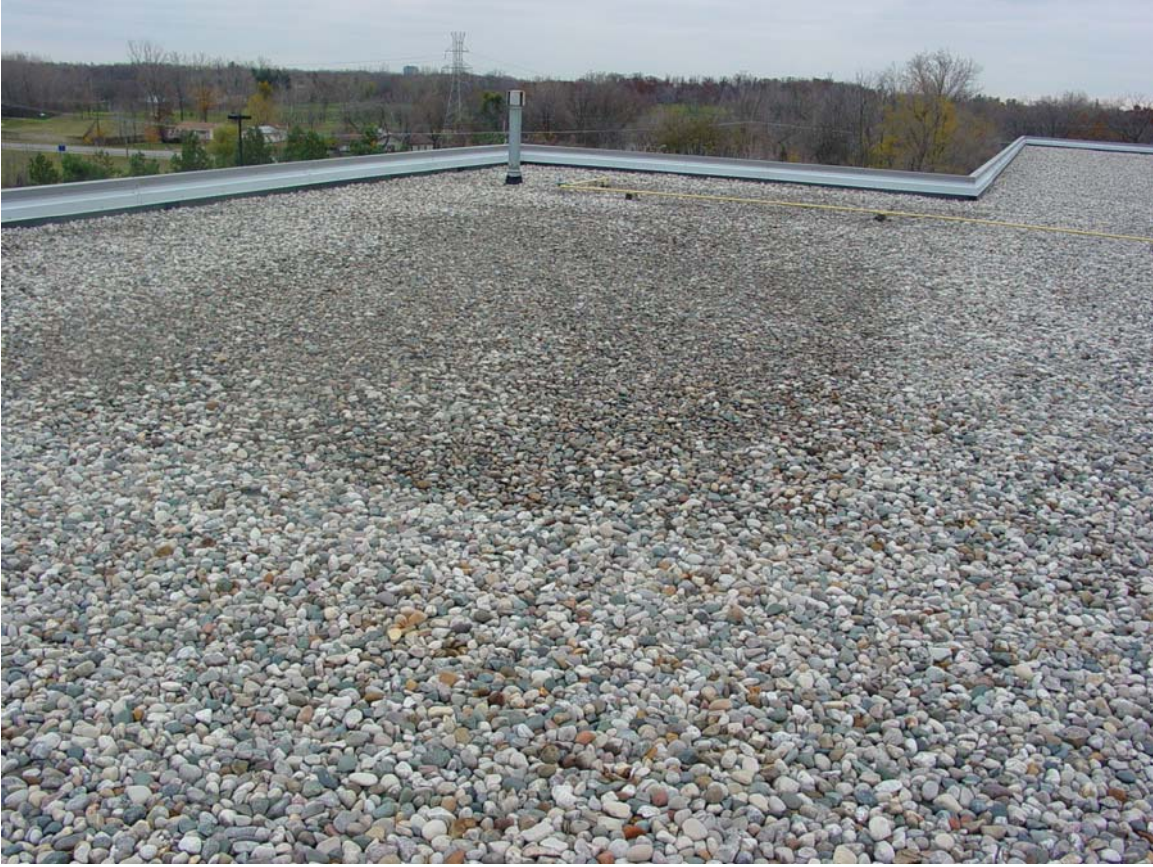
Roof - areas of water ponding.

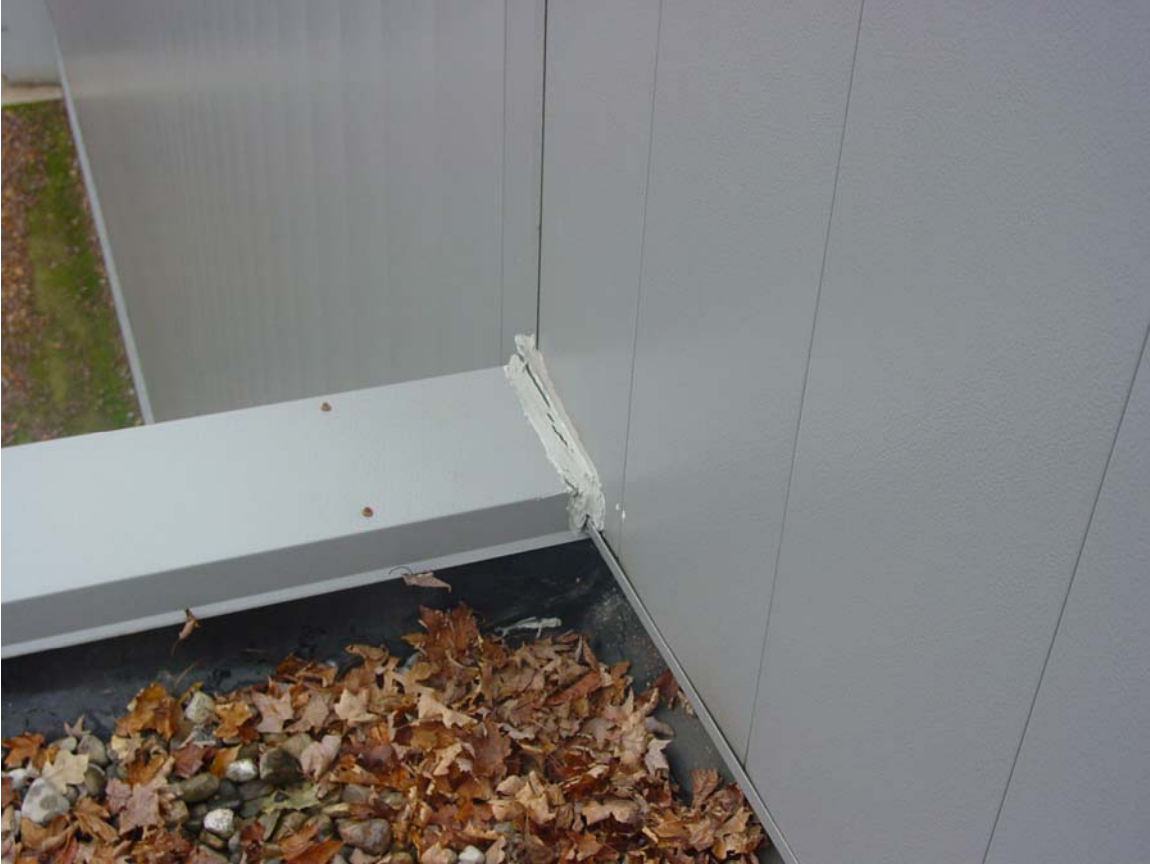
Roofing material showing signs of shrinkage.

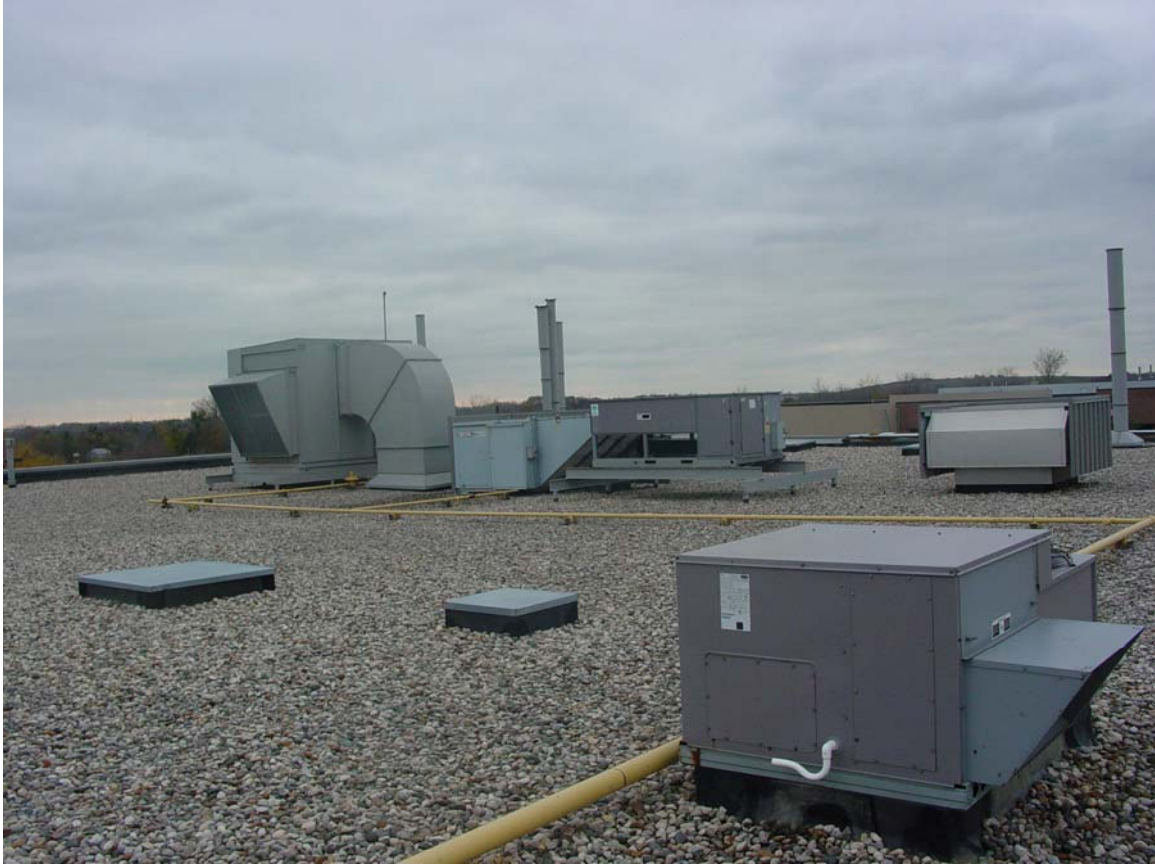
Roof top mechanical.

There are 6 rooftop HVAC units that appeared serviceable during our inspection. The systems are Carrier and AAON systems that are maintained as needed only. The units appear to have been cleaned and maintained regularly. The tenants are responsible for maintaining the HVAC systems. The two air make up units appear in good condition. The building was originally built with just the smaller of the two units and then Hayden added the larger unit after occupying the building.

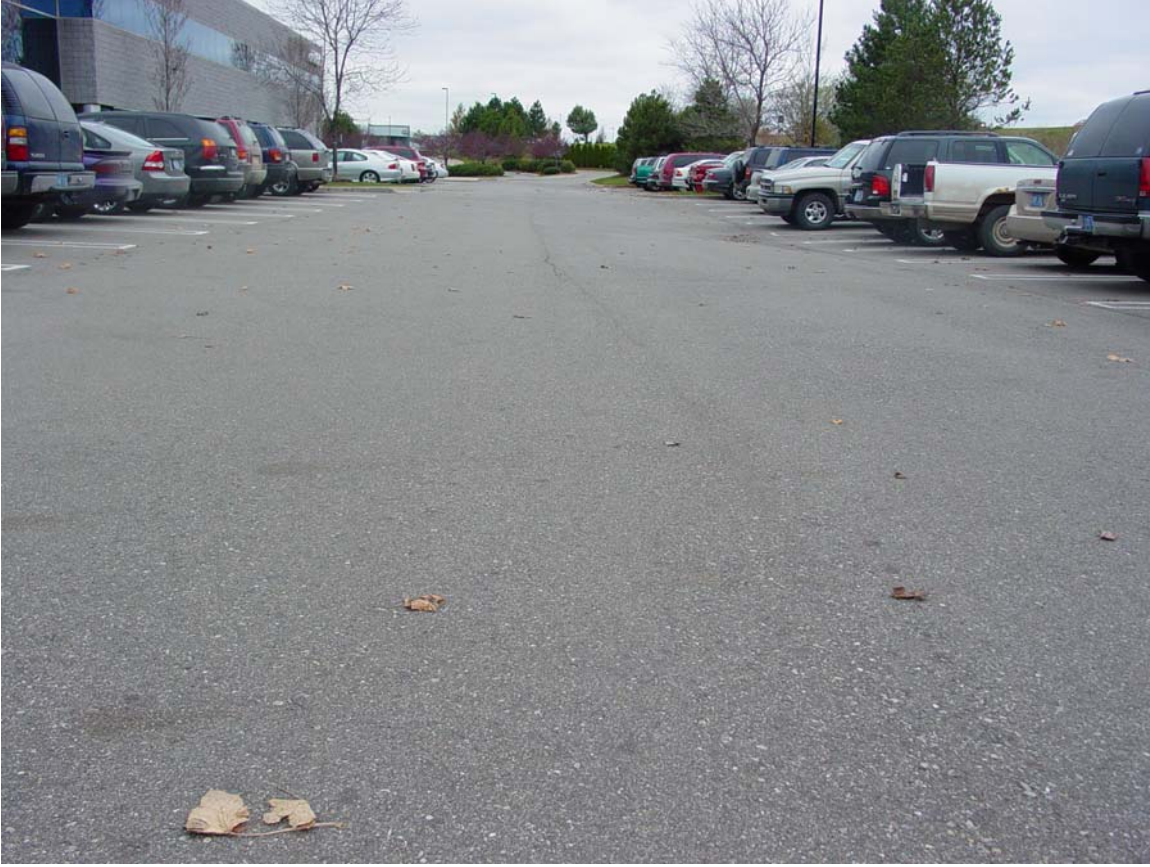
Asphalt seal coating needed.

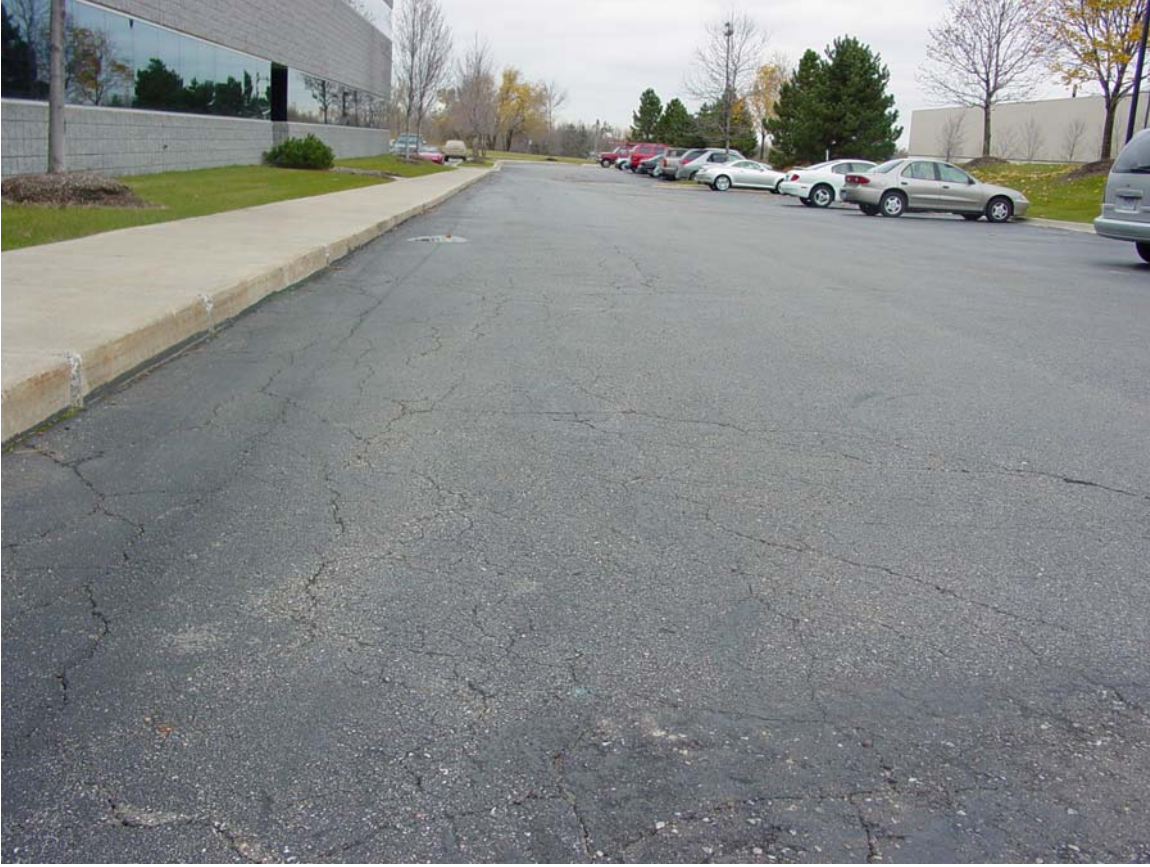
Condition of asphalt needs sealant and repairs. Cracking and tire groves.

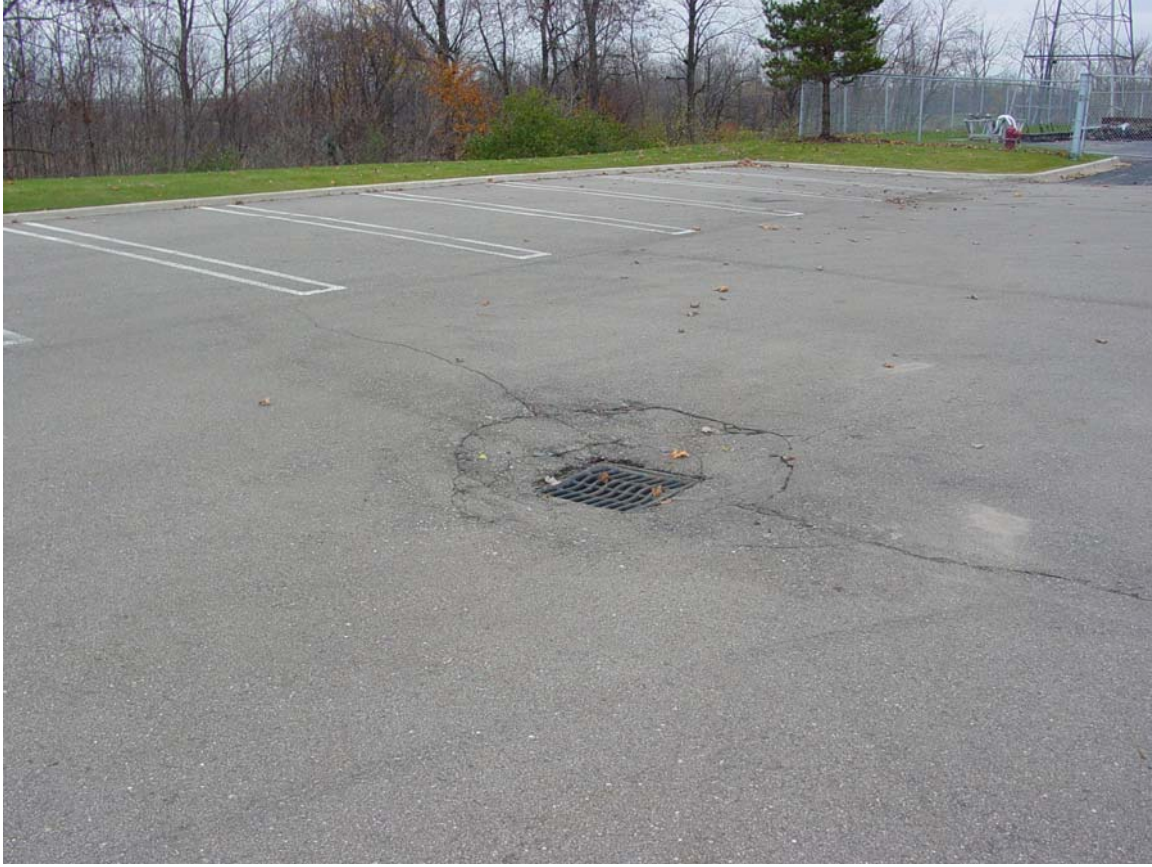
Catch basins need concrete collars and repairs.

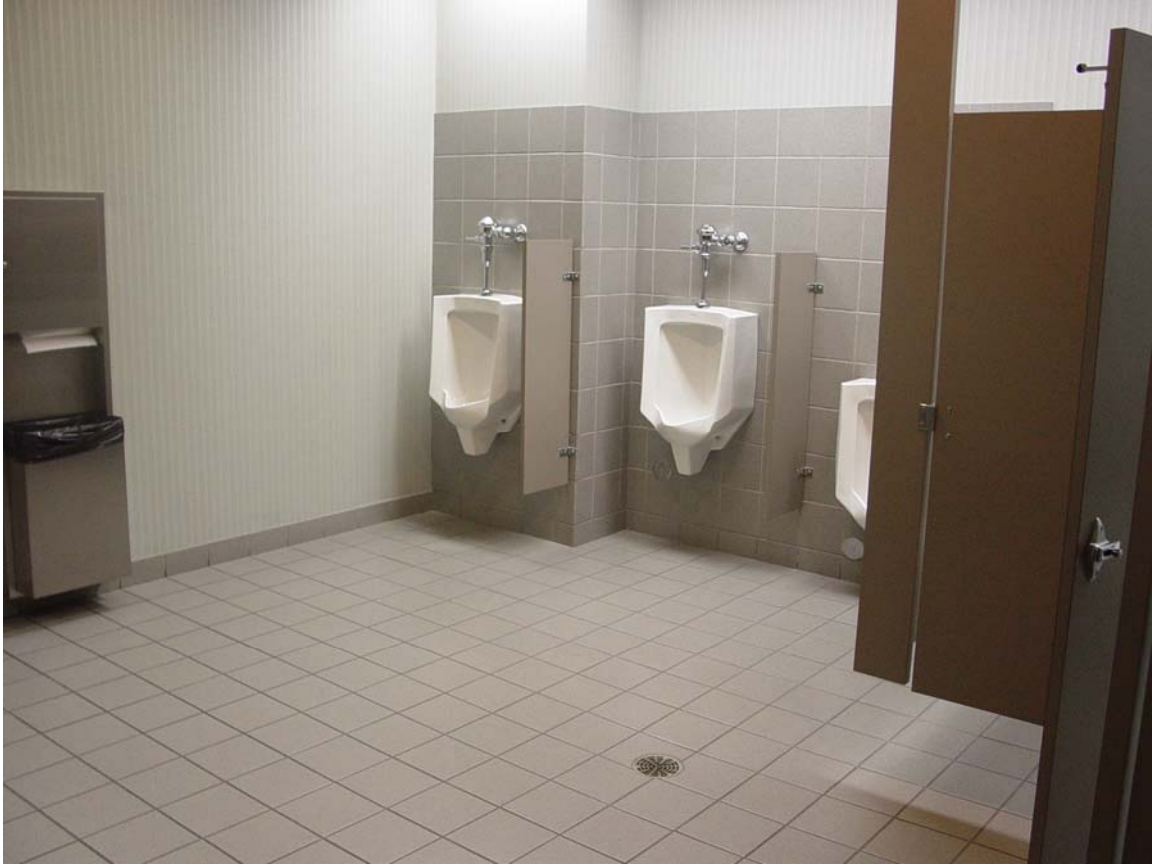
Bathroom facilities appear in good condition.

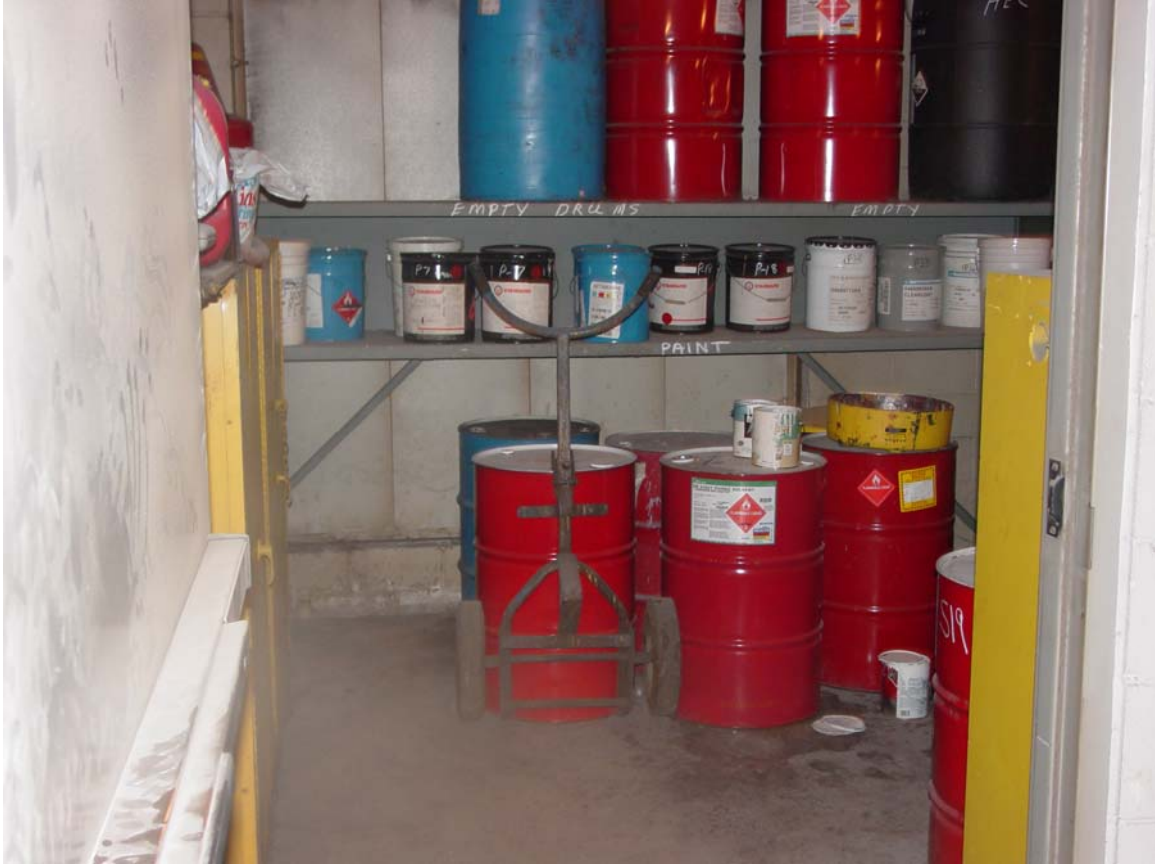
and in good condition. There is an explosion room in the manufacturing area of the building with blowout panels to the exterior of the building. The prototype area was observed, but no pictures were allowed to be taken due to their security policy. The remaining manufacturing area was observed and we did not find any defects in this area either.

Explosion proof room and exterior wall with blow out panels.

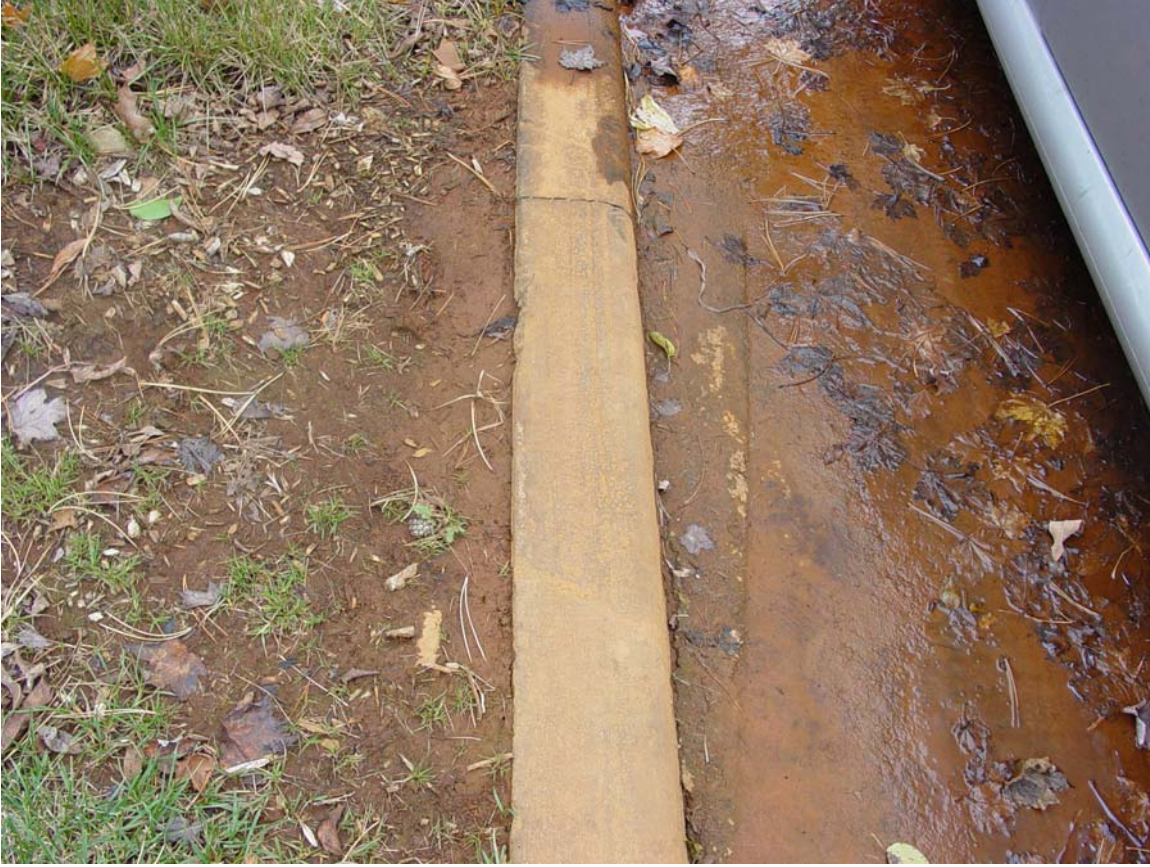
Iron deposits on concrete curb, asphalt, and ground.

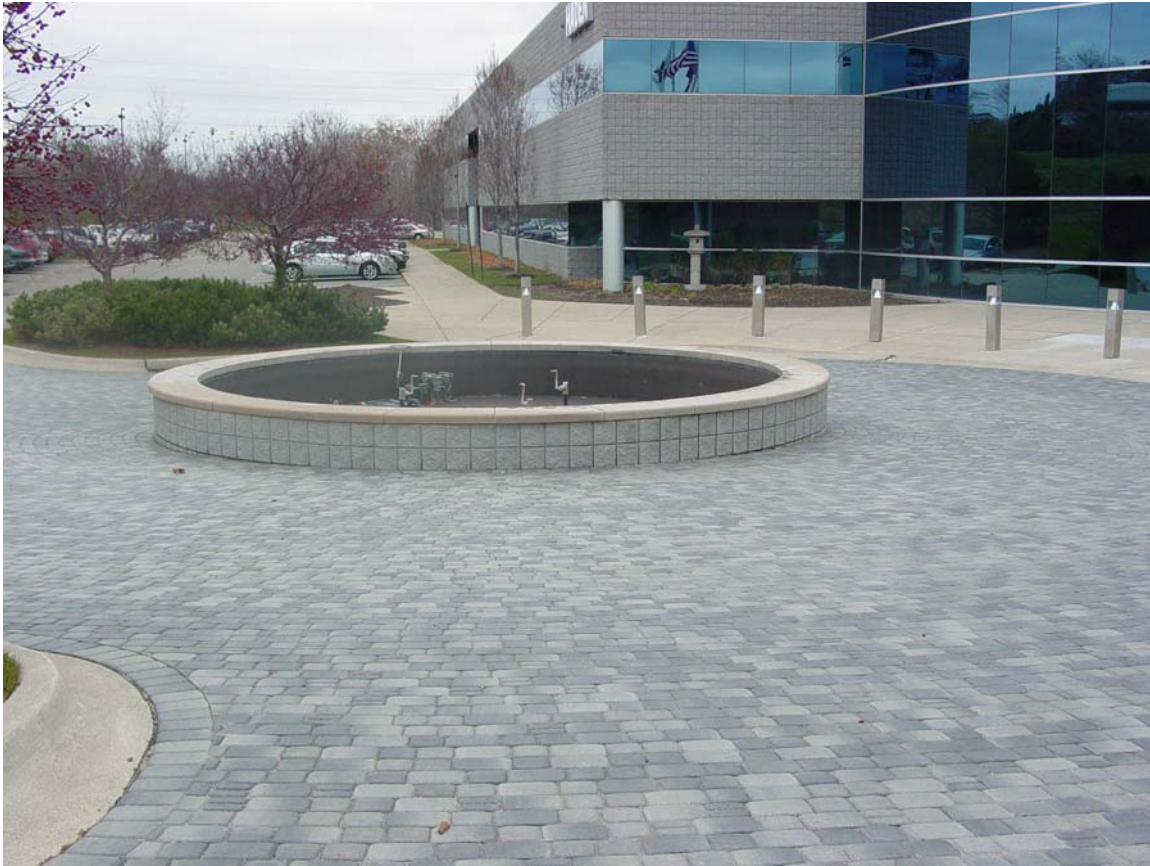
The site around the property is sloped away from the building and to the south. The land east of the property is adjacent to the I-00 freeway and it slopes toward the building. This slope is far enough away from the building that it will not cause a problem with water, ice, or snow. The property is very wet at this time and the manager did mention that from fall to spring the property is always wet and has continuous water movement in the drainage system. The east slope of the property which is adjacent to I-00 near the front area of the building has an area where the curb and asphalt is stained orange. The staining is believed to be from iron and other minerals in the ground. The parking lots and drives do show signs of deterioration that is thought to be caused by the ground movement and settling. The ground movement also appears to be causing significant cracking and alligating of the surface the asphalt. The deterioration and cracking around the catch basins will need to be repaired. It is our recommendation that concrete drain collars with cross sections be installed around the catch basins as they have a longer useful life compared to asphalt alone. The concrete aprons for the front and rear drives have significant deterioration and are in need of replacement. The manager told us that the replacement of the approaches, asphalt repairs to the parking lot and drives, and catch basin repairs are in the budget for next year in the amount of \$30,000.00. The following budgets are suggested for future maintenance; seal coating at \$7,626.00 every 3-4 years, asphalt repairs at \$50,000.00 every 3 years. The chain link fence around the building and shipping and receiving area will require repairs and we suggest budgeting around \$1,500.00 to cover the cost of these repairs. There are horseshoe boxes on the west property line. At the main entrance of the office portion of the building is a decorative water fountain that is in need of repairs. The brick pavers in this area have been replaced due to destruction to the bottom side and ground surface. The interior of

Fountain and brick paver drive.
Fountain being worked on 2005 and pavers replaced in 2003/4 for deterioration from the bottom side.

the fountain needs to be sealed and the limestone caps need resenting. There are electric towers passing through the south property line and a retention pond is situated behind the towers which collects all the water from the surrounding complexes. There is a piece of property on the northwest corner that is adjacent to Pacific drive and the next main street that the tenant has purchased, I did not enquire as to their plans for this piece of property.
